Hayotova Nafisa Zakirovna

STATE OF HISTORICAL MONUMENTS IN BUKHARA AND PROBLEMS OF THEIR PRESERVATION

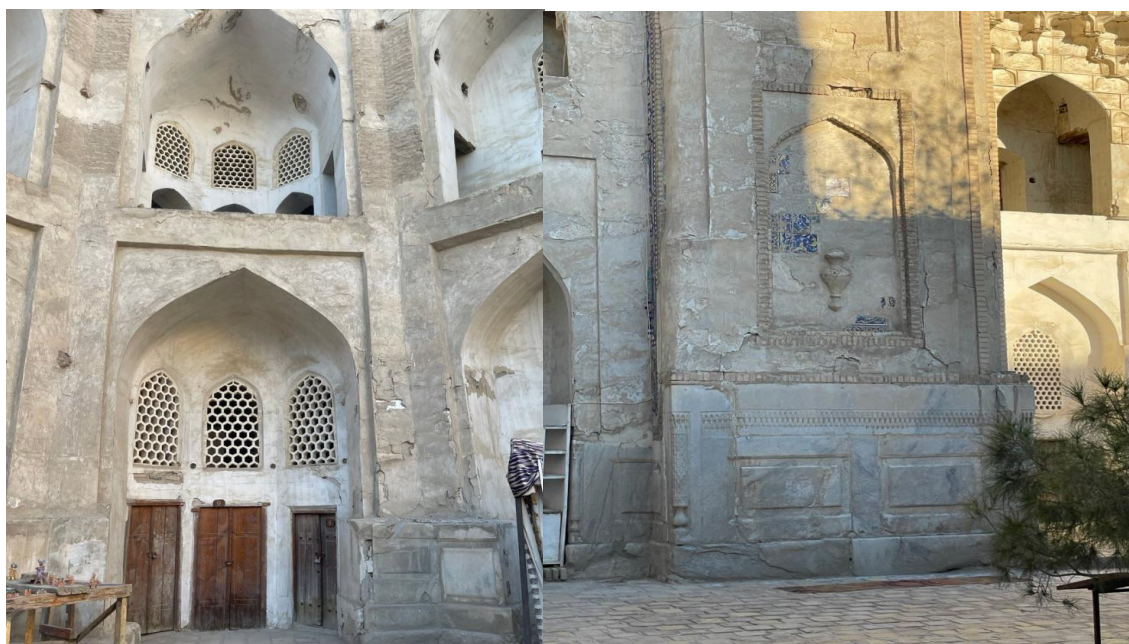
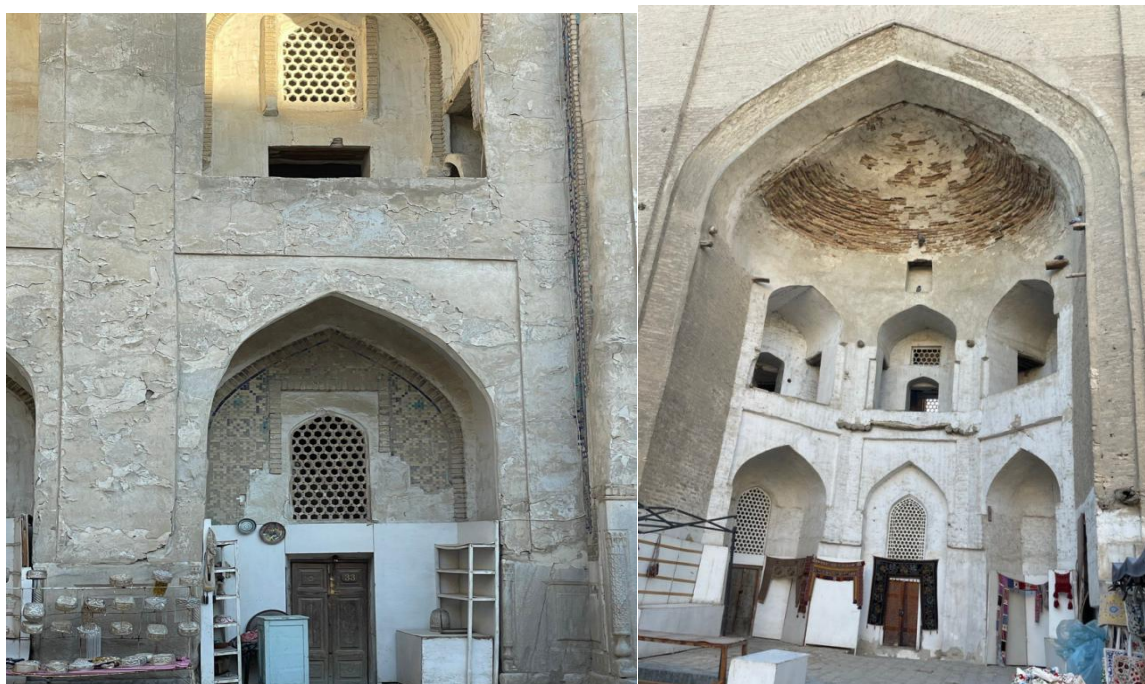
Madrasah of Abdulaziz Khan (1651-1652 years). 2023 year

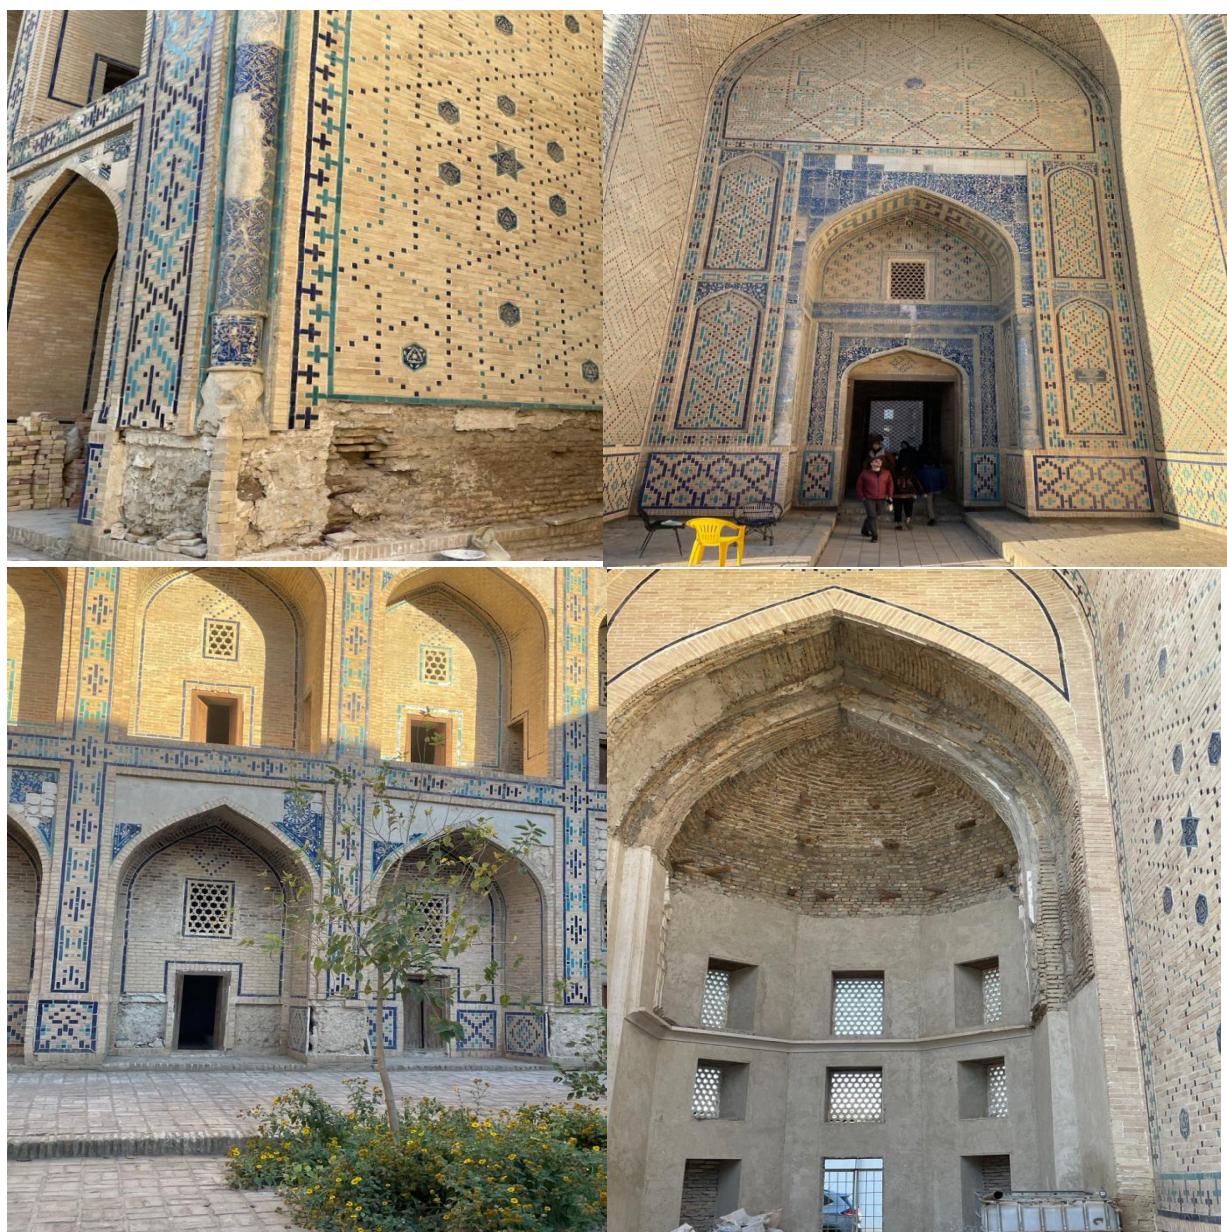
Ulugbek Madrasah (1417). 2023 year.

the soil under the Ulugbek madrasa, the front part of the building and the porches in the yard were cracked and deformed. This situation was clearly demonstrated in the Kashmadrasa, which includes the Modari Khan and Abdullah Khan madrasas.[5].Also, the erosion of the upper part of the historical monuments due to precipitation and the damage of the bricks under the walls due to atmospheric precipitation and the rise of underground seepage water have increased.

The general condition of some madrasas in the city is also related to soil erosion, including the external and internal foundations of the Ulugbek madrasa. Today, restoration works are being carried out in this historical monument. As a result of the uneven settlement of the building's soil, the front part of the madrasa and the porch walls in the courtyard were deformed. This situation can also be seen in Rashid Madrasah. Atmospheric rains and the rise of underground seepage caused the destruction of the bricks under the building and the monument fell into an abandoned state.

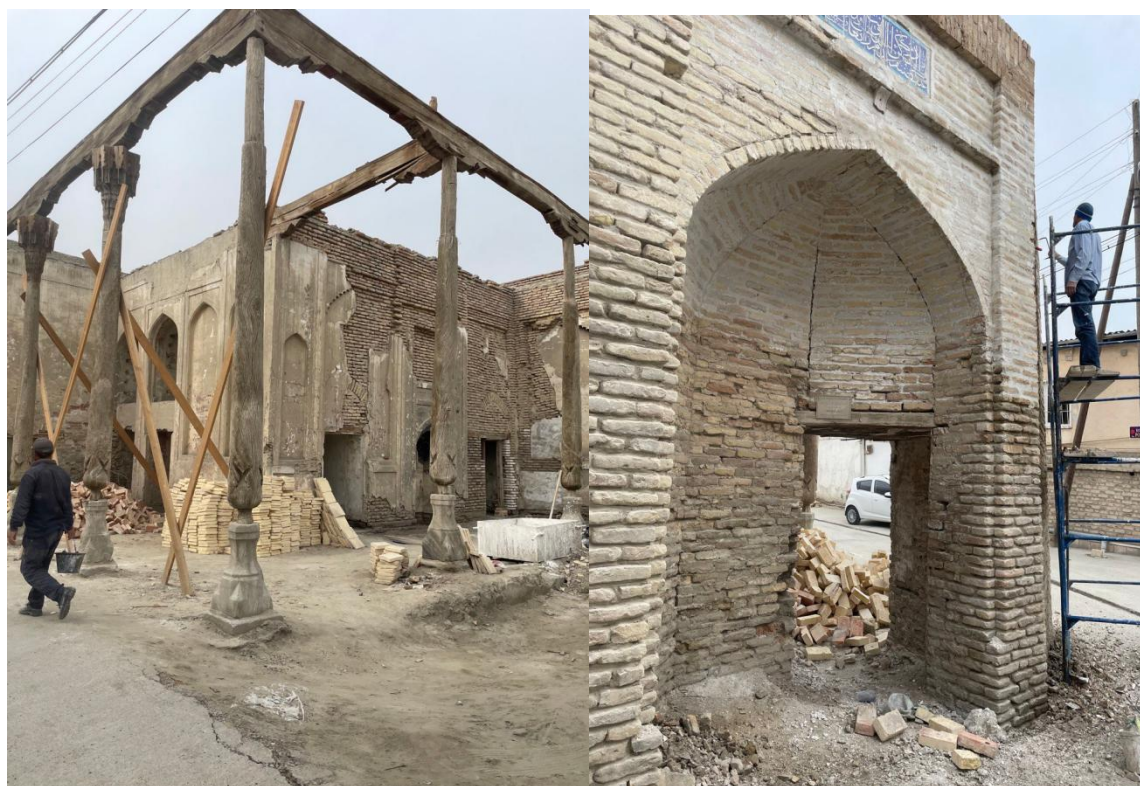
3- Picture. Dostum Chuhraogosi Mosque (1585-1585). 2023 year
